Low Resistance TIVA

Backside Die-level

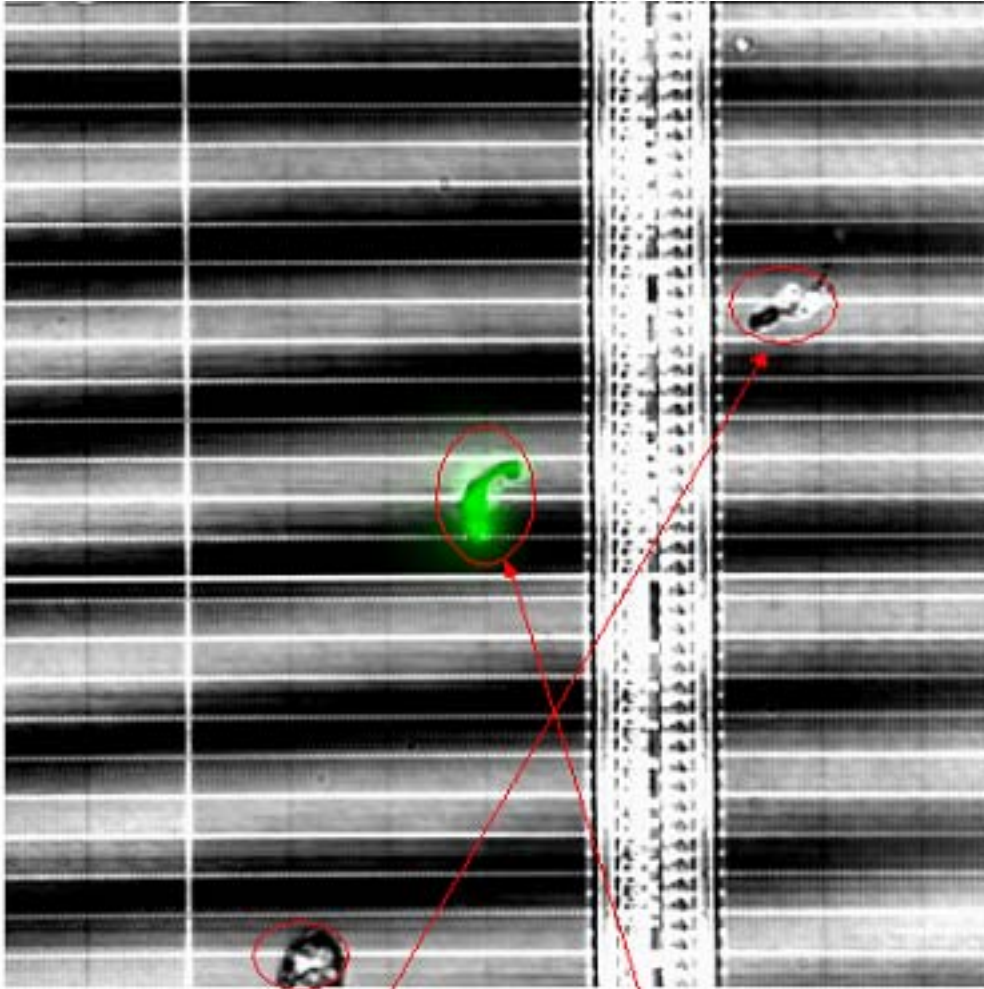
Backside TIVA image of particle-induced non-planar dual damascene failure. Vcc to Vss resistance was $\sim 5 \Omega$. Images and data obtained with the Infrascan 200.
